# **West Lothian Council**

## **Condition Survey**

**Deer Farm Building 001 – Animal Shed**

**Beecraigs Country Park, Linlithgow,  
EH49 6PL**

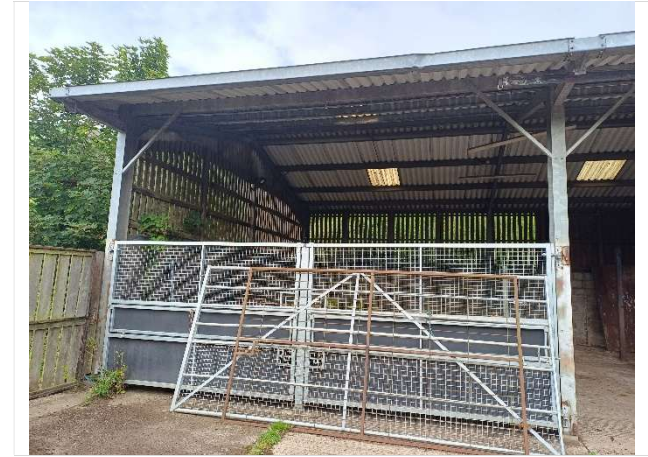
- 4.8.2 The rainwater goods were noted to be in satisfactory condition, with a minor defect to the front gutter, however, this does not show to be causing any leaks or functional issues. There is also significant debris and vegetation visible within the gutters. It is recommended that the gutters are overhauled to remove debris and vegetation and realigned to an appropriate fall.

**03** Minor dent in guttering to LHS of front elevation.

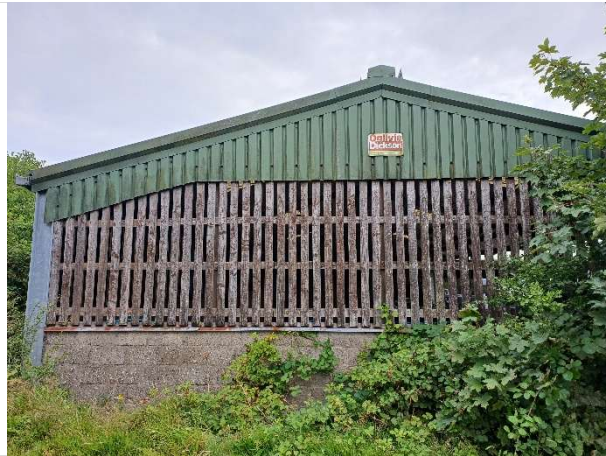
- 4.6.2 The timber cladding was observed to be in poor condition. It is recommended as a medium priority that all the timber is redecorated with wood stain.

**05** General view of left elevation showing weathered wooden cladding and vegetation growth.

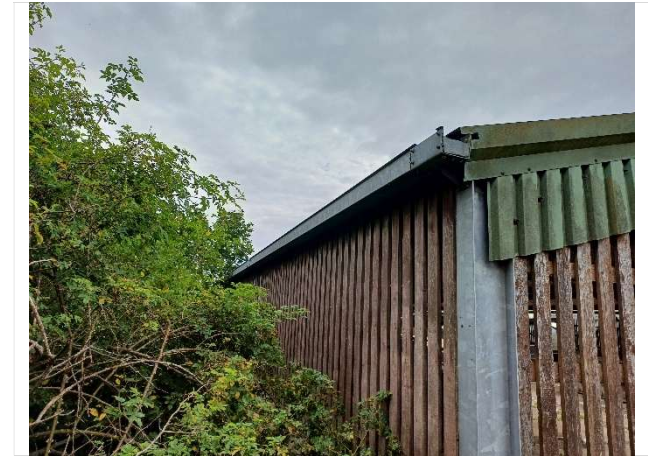
- 4.7.5 The paved surrounding is in satisfactory condition. Removal of vegetation growth from slab joints should be completed as a low priority.
- 4.7.6 The vegetation and landscaping to the rear of the building is in satisfactory condition. However, it is recommended that a standard priority is set to cut back and clear the vegetation in order to maintain a clear perimeter to help reduce moisture retention and provide access to the rear gutters.

**06** General view of rear elevation and guttering, showing vegetation growth.

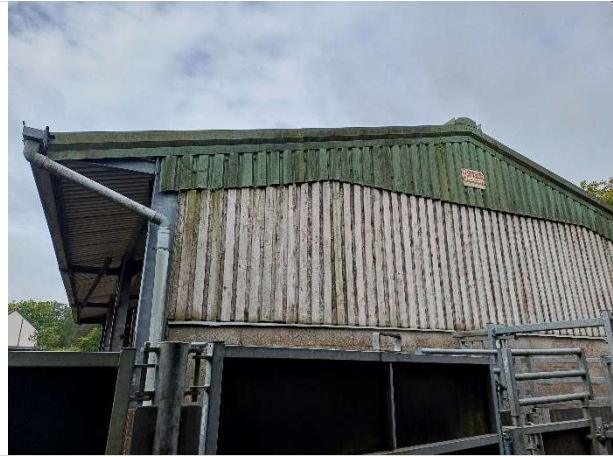
**07**

General view of right elevation. Wooden cladding discoloured and weathered. Upper metal cladding showing minor corrosion and dirt build up.

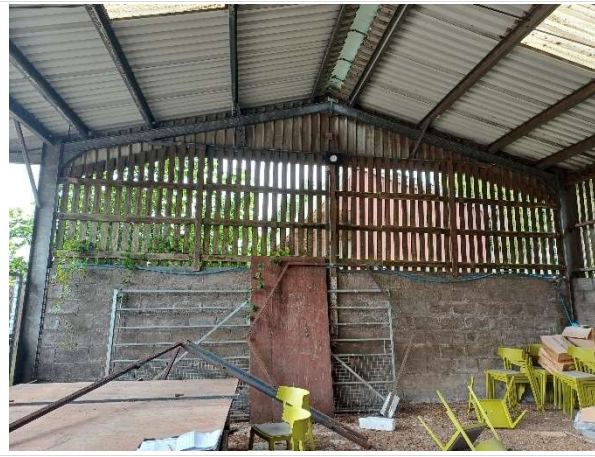
**08**

General view of internal LHS elevation. Noticeable signs of age and surface wear with space cluttered with items.

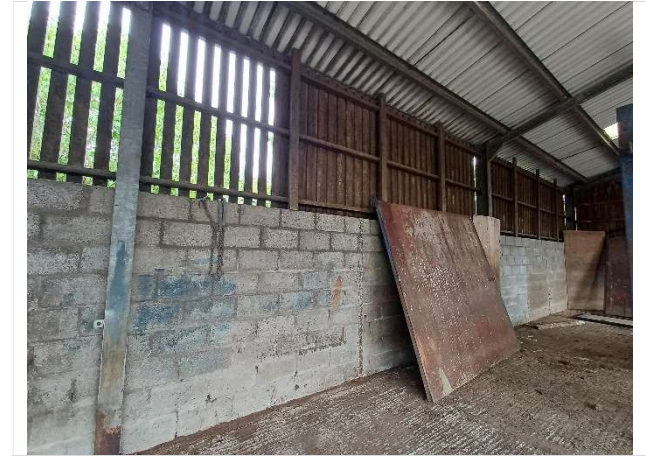
**09**

General view of internal rear elevation. Overall condition showing signs of age and surface wear.

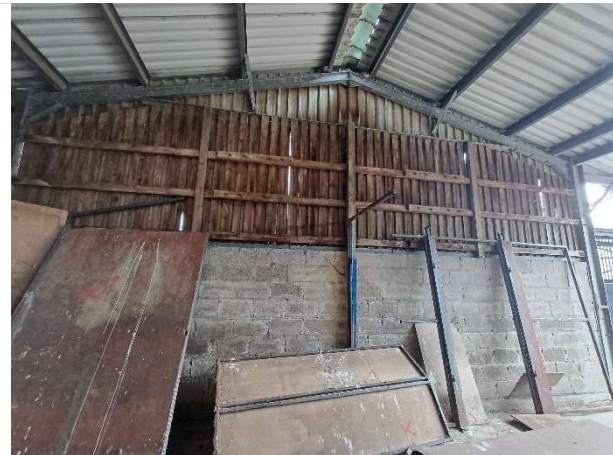
**10**

General view of internal RHS elevation. Overall condition showing signs of age and surface wear.

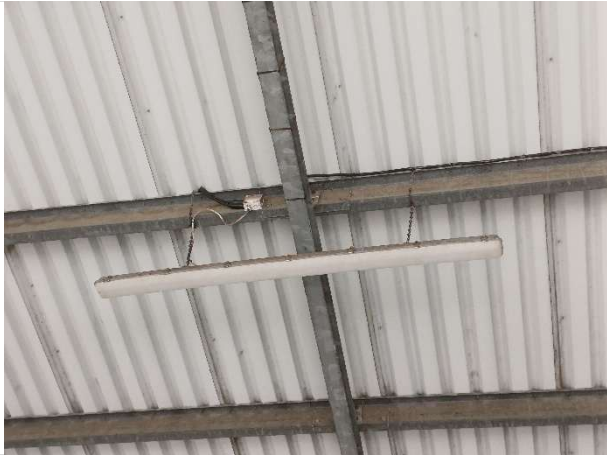
**13**

- 4.10.1 There are 4no strip lights within the property, mounted from the ceiling by chains. It was observed that 1 of the chains to 1no light is broken, with the light hanging by the power cord.

- 4.10.3 The strip lighting is in poor condition due to the age and as well as the broken chain to 1no of the lights causing a health and safety concern. It is recommended at a category 1.1 that the broken chain is removed and the 1no light is rehung with a new chain to secure the fitting.
- 4.10.4 The floodlighting is in good condition with no significant defects.

Example of strip lighting within building.

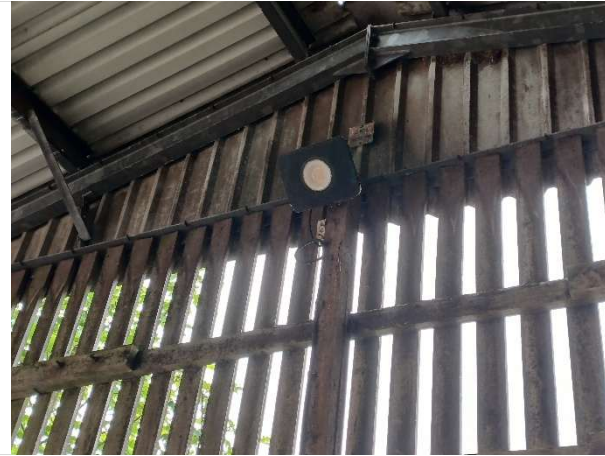
**14**

Wall mounted flood lighting within building.

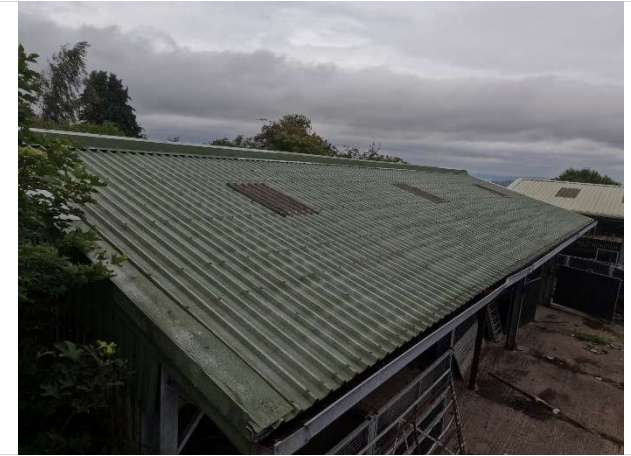
**15**

General view of front pitch. Minor damage to corner of roof covering and second view of dent in gutter.

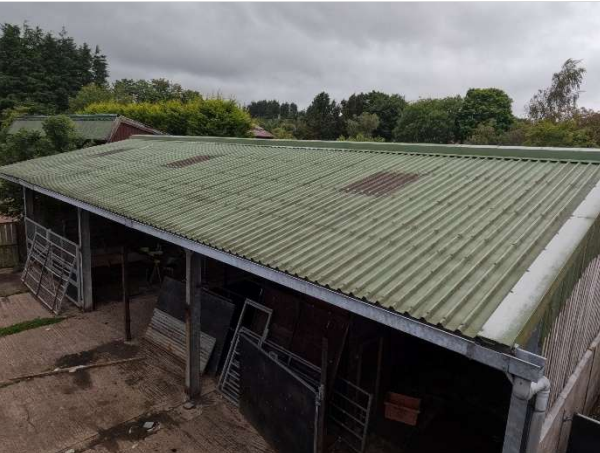
**16**

- 4.2.4 The roof structure was observed to be in satisfactory condition with no significant defects noted.
- 4.2.5 The corrugated metal sheeting was observed to be in satisfactory condition. It is recommended that a standard priority is set to remove debris, treat rust spots with inhibitor or paint, and is inspected for leaks or damages and repair where required.
- 4.2.6 The corrugated roof lights were observed to be in satisfactory condition. It is recommended that a standard priority is set to clean thoroughly, inspect for cracks or brittleness and apply a protective coating such as deglaze to prolong the lifespan.

General view of front pitch showing minor discoloration and staining.

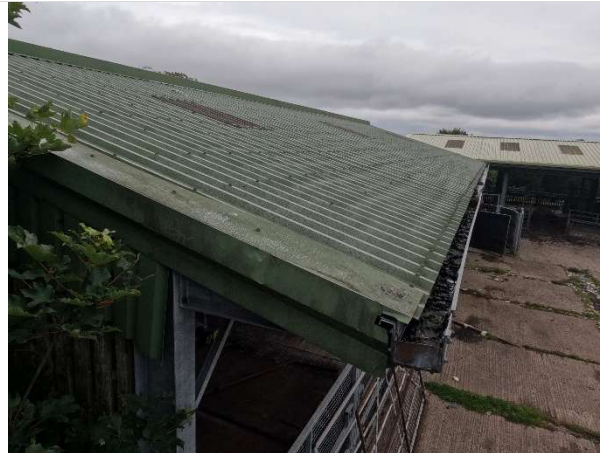
**17**

General view of front guttering showing poor condition with build of debris and dent damage.

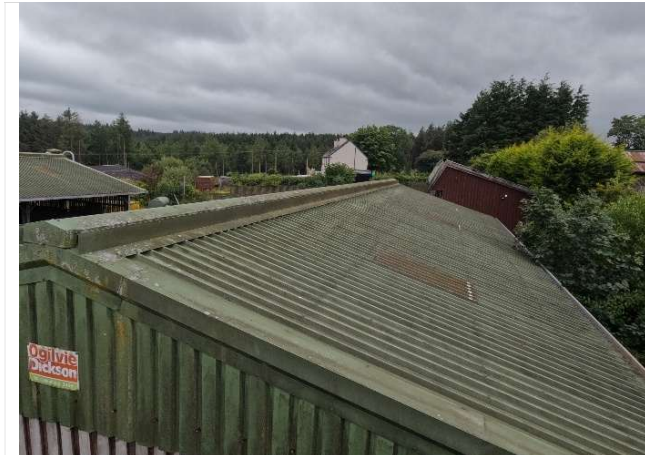
19

General view of rear pitch showing  
discolouration and weathering.
