## **Condition Survey**

**Deer Farm Building 003 – Deer Shed**

**Beecraigs Country Park, Linlithgow,  
EH49 6PL**

**August 2025**

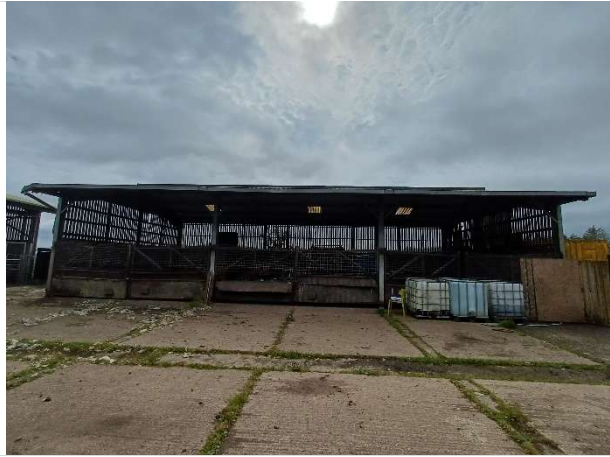
**01** General view of front elevation.

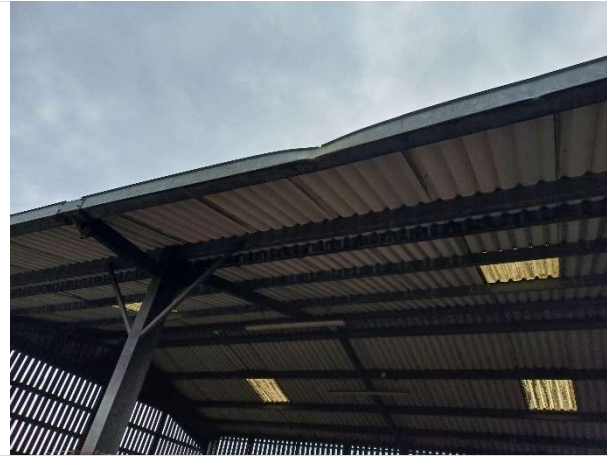
- 4.8.2 The rainwater goods were noted to be in poor condition, with various defects and significant build-up of debris and vegetation. It is recommended as a 1.2 priority to replace guttering and S-bend downpipe with deep flow, extruded aluminium, polyester powder-coated box gutter.

**02** Damage to guttering at front elevation.

- Replace guttering and S-bend downpipe with 140 x 100mm mould gutter, extruded aluminium, polyester powder-coated finish.
  - Replace all broken or missing wooden slats to cladding and redecorate all timber cladding.

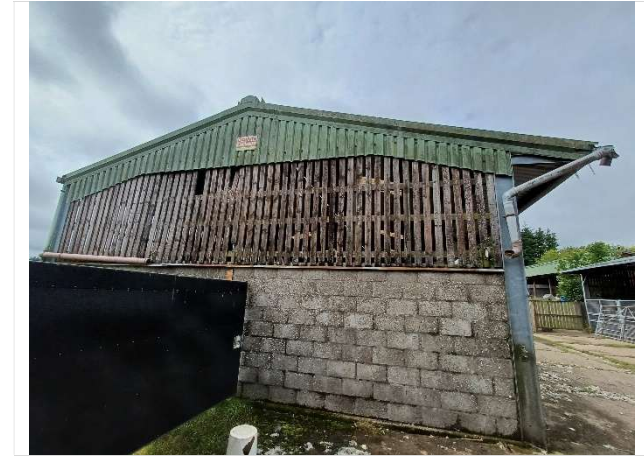
**03** General view of left elevation showing poor condition and signs of deterioration.

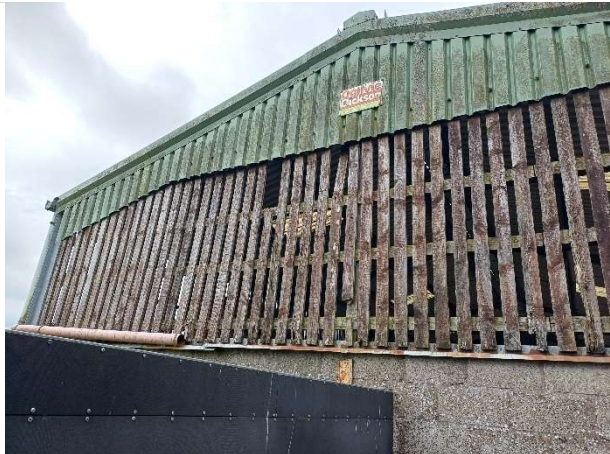
- 4.4.6 The concrete block was observed to be in poor condition. It is recommended that all friable mortar be raked and repointed as a standard priority.
- 4.4.7 The wooden slats were observed to be in poor condition. It is recommended that all broken or missing slats are replaced as a medium priority.
- 4.4.8 The metal cladding was observed to be in satisfactory condition with no significant defects noted.
- 4.4.9 The steel gates were observed to be in satisfactory condition. They were observed to be weathered and soiled but with no significant defects. It is recommended that all gates are overhauled for easy access, set as a standard priority.
- 4.4.10 The concrete block was observed to be in poor condition. It is recommended that all block work is cleaned thoroughly to remove build-up of moss.

**04** Metal cladding showing rust and discolouration. Section of wooden slats missing, damaged and significant deterioration.

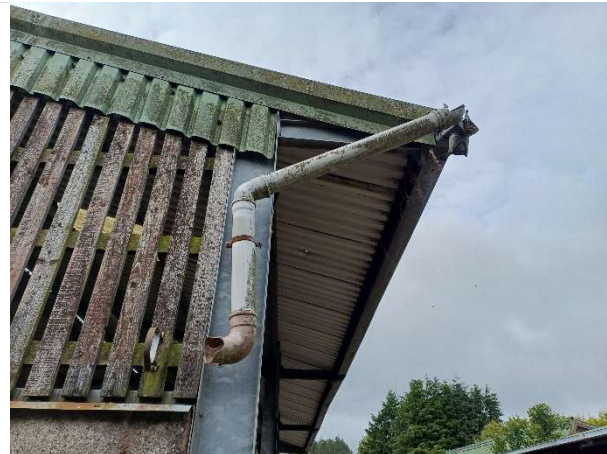
**05** Poor condition of downpipe, showing missing section and discolouration highlighting possible leaks

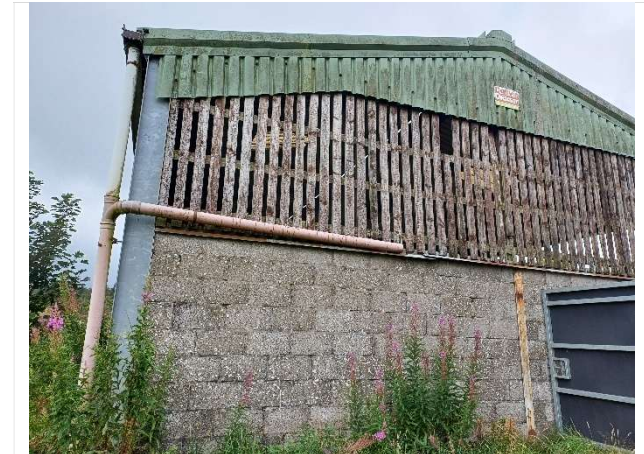
**06** Second general view of left elevation showing poor condition and signs of deterioration and vegetation growth.

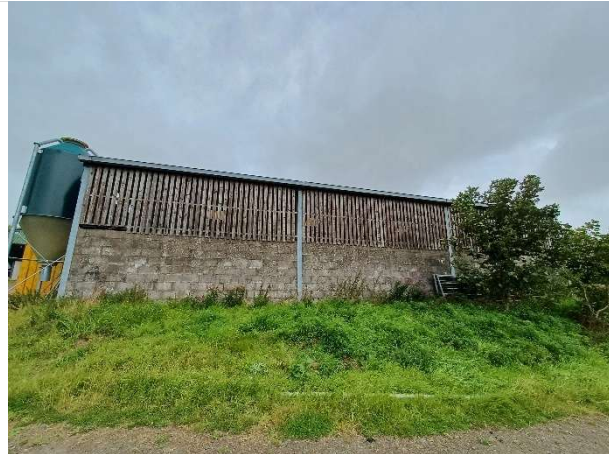
**07**

General view of rear elevation.

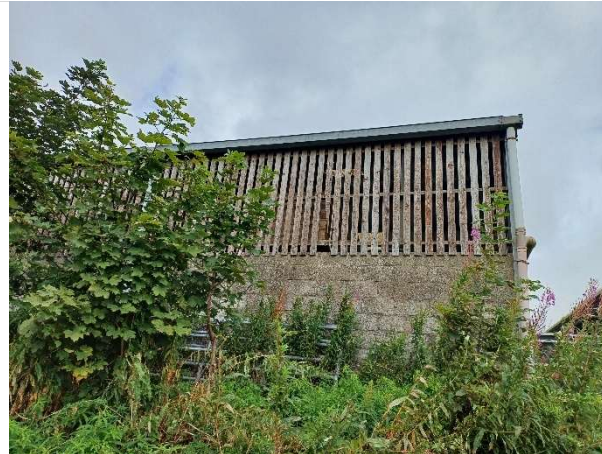
**08**

- 4.4.2 The external wall structure of the left, right and rear elevations comprises wooden slats from mid-height to roof. Various isolated areas of damaged or missing slats were noted. The cladding overall is also showing to be weathered.

Poor condition of wooden slats, showing missing sections and weathering. Vegetation growth.

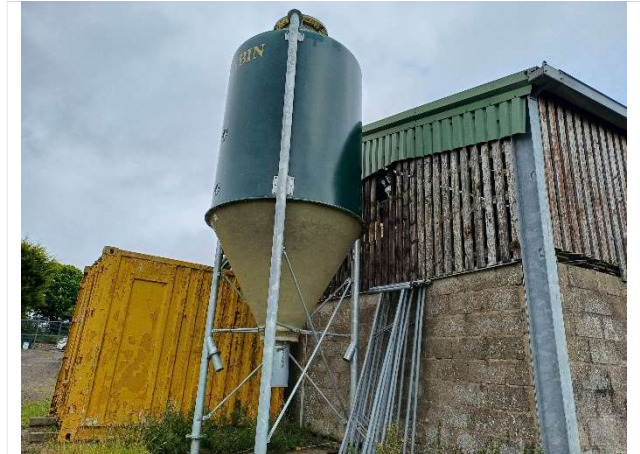
**09**

General view of right elevation.

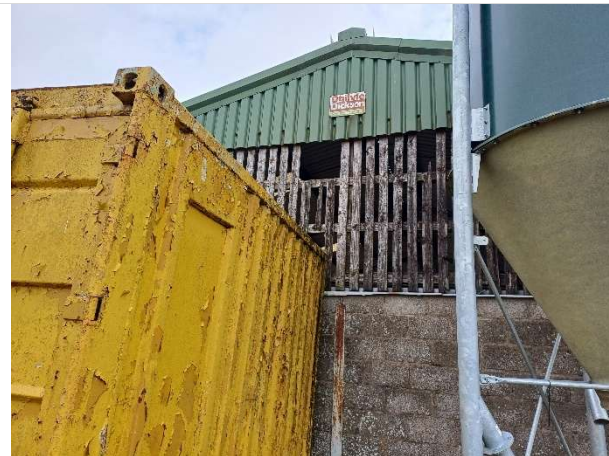
**10**

Poor condition of wooden slats, showing missing sections and significant deterioration.

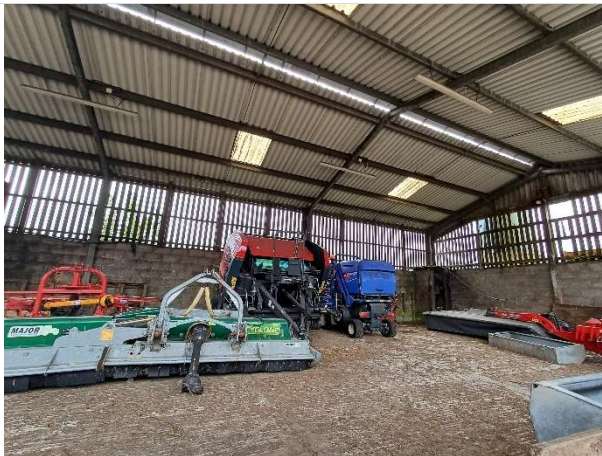
**11**

General view of internal space.

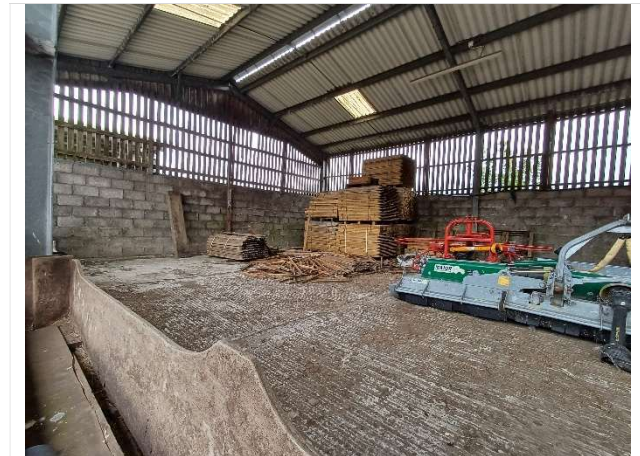
**12**

General view of internal space.

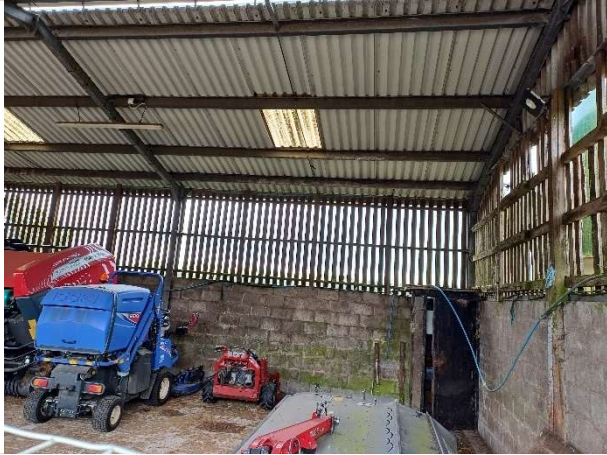
13

- 4.4.4 The external wall structure of the front elevation comprises of three steel gates. These were locked at the time of the survey.
- 4.4.5 Internally, it is observed that there is significant build-up of moss on the blockwork, particularly to the right elevation and the rear elevation to the right.

Lower section of rear internal elevation showing moss or algae growth suggesting damp conditions.

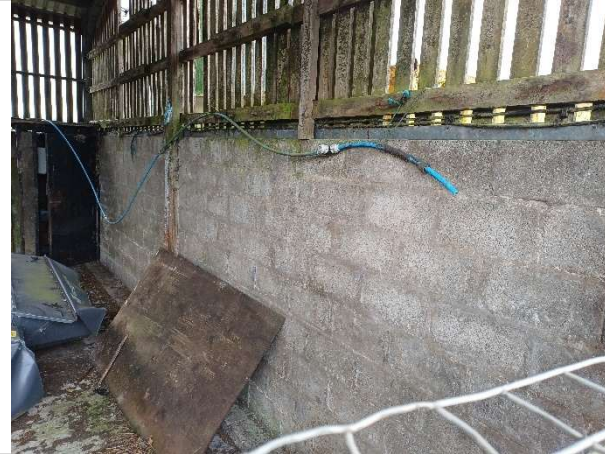
14

Hose pipe wall mounted to RHS internal wall.

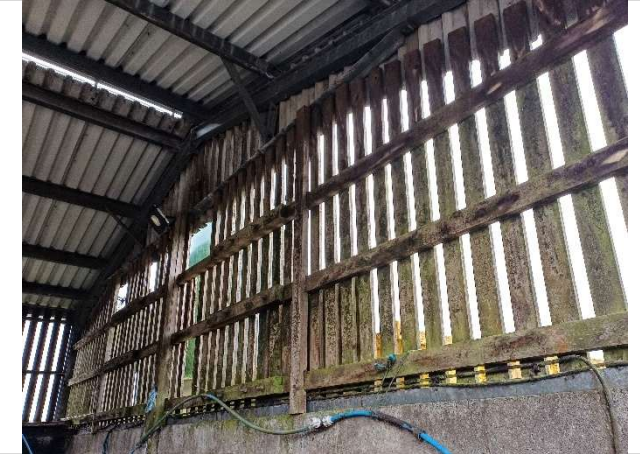
15

Wooding cladding internally in poor condition, including moss or algae growth suggesting damp conditions.

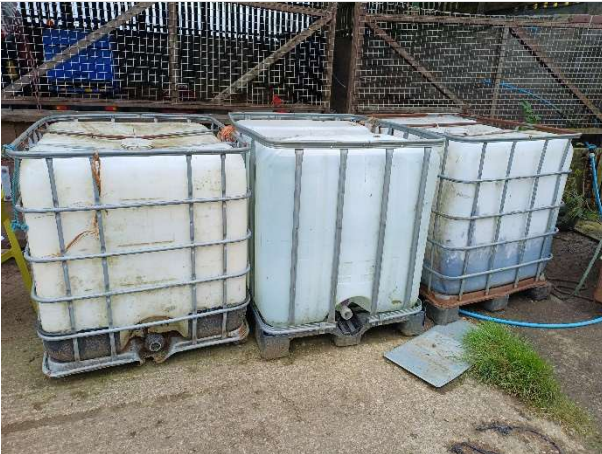
16

Plastic containers located outside front elevation, for storing water.

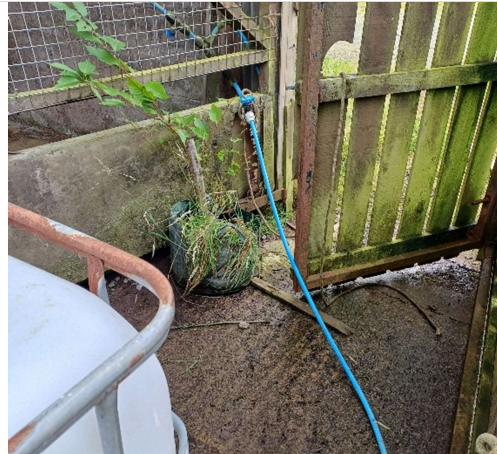
17

Hose pipe from storage tanks going into building

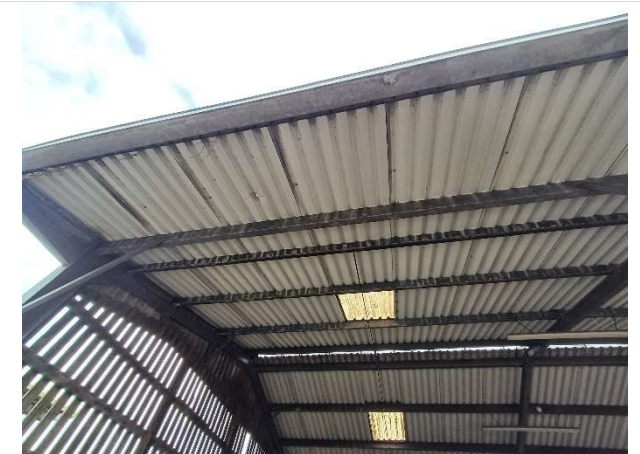
18

General internal view of roof cover and structure.

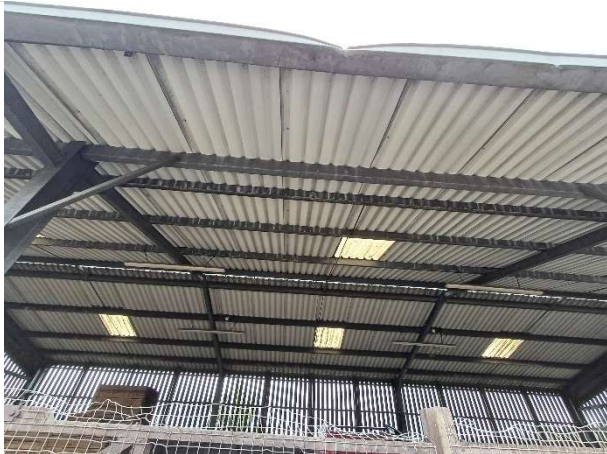
**19**

General internal view highlighting dent in gutter and minor signs of discolouration to metal beams

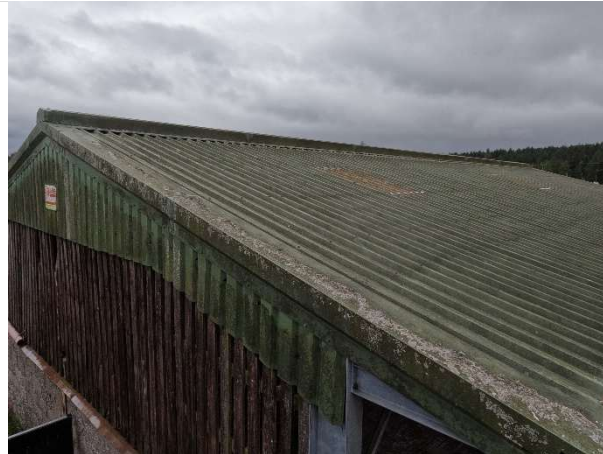
**20**

- 4.2.4 The roof structure was observed to be in satisfactory condition with no significant defects noted.
- 4.2.5 The corrugated profile sheeting was observed to be in satisfactory condition. It is recommended as a standard priority that debris is removed, rust spots treated with inhibitor or paint, and the sheeting is inspected for leaks or damages and repaired as needed.
- 4.2.6 The corrugated roof lights were observed to be in satisfactory condition. It is recommended as a standard priority that the rooflights are cleaned thoroughly, inspected for cracks or brittleness and a protective coating, such as Deglaze, applied to prolong the lifespan.

General view of front pitch showing poor condition.

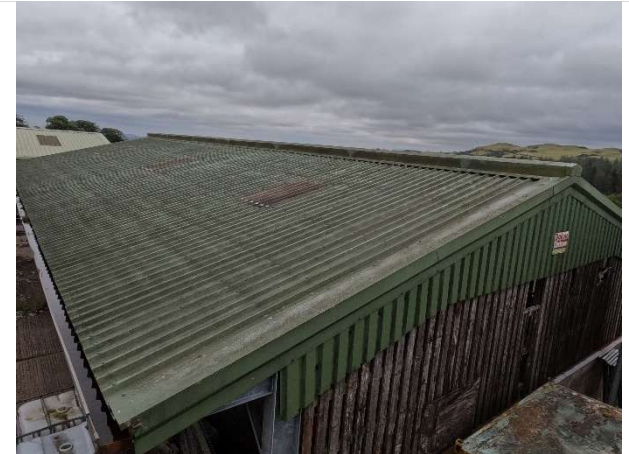
**21**

General view of front pitch.

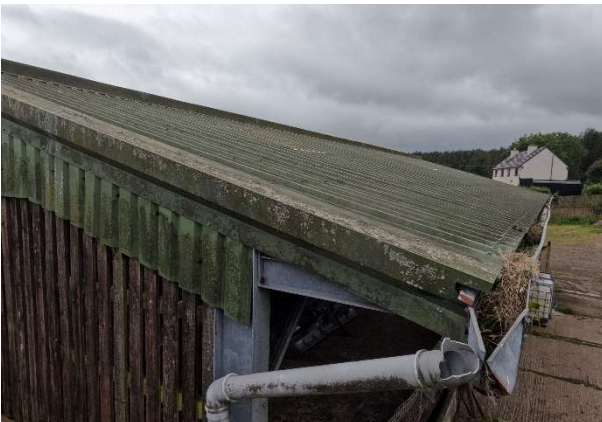
**22**

General view of front guttering showing poor condition with build-up of debris and damage.

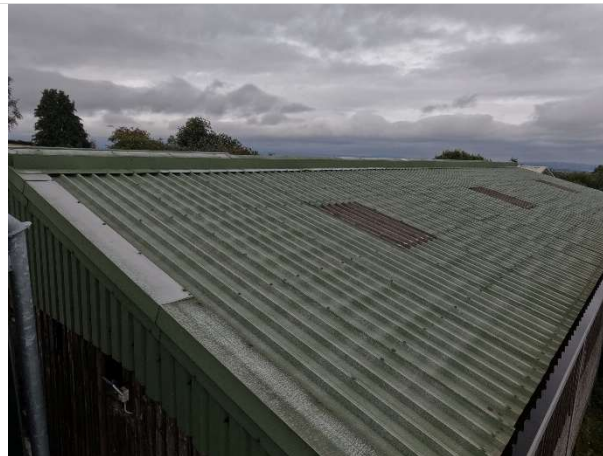
**23**

General view of rear pitch.

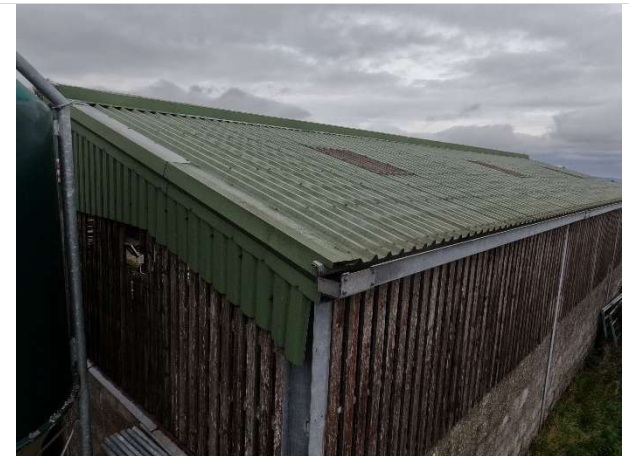
**24**

General view showing minor movement to metal cladding on external RHS.

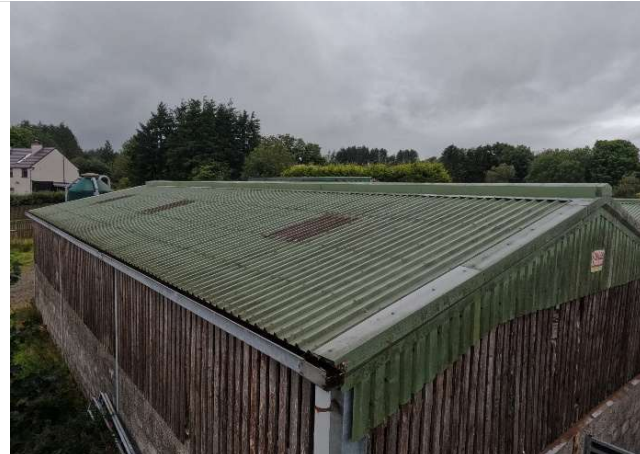
**25**

General view of rear pitch and elevations.
