# **West Lothian Council**

## **Condition Survey**

**Deer Farm Building 002 – Viewing  
Shed**

**Beeccraigs Country Park, Linlithgow,  
EH49 6PL**

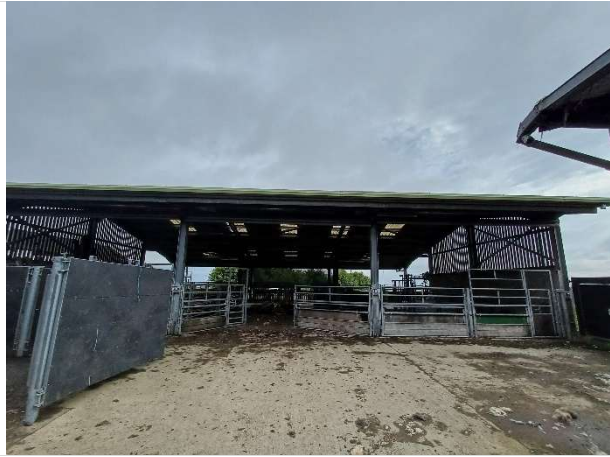
**01** General view of front elevation.

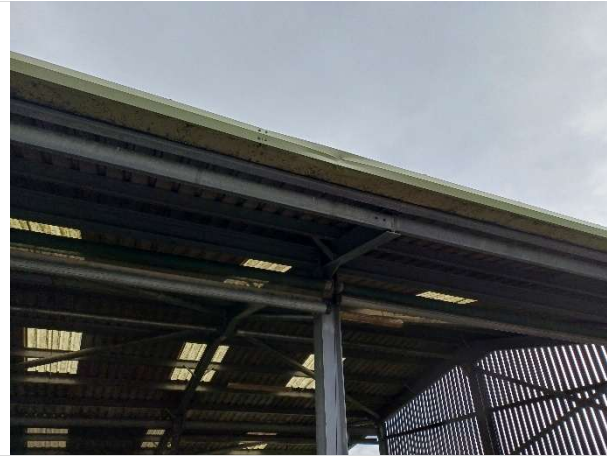
- 4.8.3 The rainwater goods were noted to be in satisfactory condition, with a minor defect to the front gutter, however, this does not show to be causing any leaks or functional issues. There is also significant debris and vegetation visible within the gutters. It is recommended that the gutters are overhauled to remove debris and vegetation and realigned to an appropriate fall.
- 4.8.4 The downpipe is observed to be in bad condition as it is missing. It is recommended that a new downpipe is fitted.

**02** Dent to guttering on front elevation.

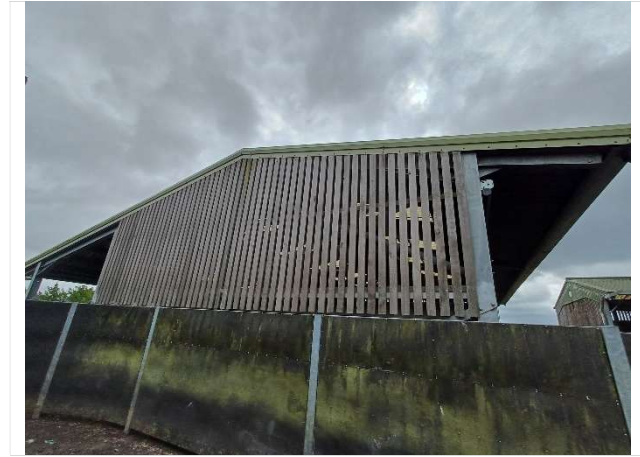
**03** General view of left elevation.

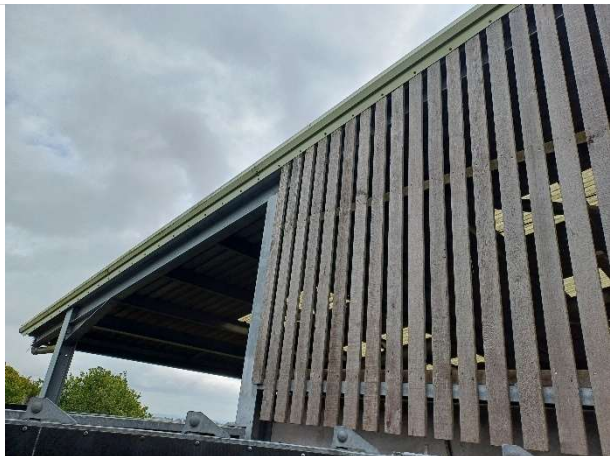
**04** Wooden cladding on left elevation in satisfactory condition.

- 4.6.4 The external timber cladding was observed to be in satisfactory condition. It is recommended as a medium priority that all the external timber is redecorated to prolong its lifespan.
- 4.6.5 The wooden fencing to the rear of the building was observed to be in satisfactory condition. It is recommended as a medium priority that both faces of the fencing is redecorated to prolong its lifespan.
- 4.6.6 The internal timber cladding was observed to be in satisfactory condition. It is recommended as a standard priority this internal timber cladding is redecorated.

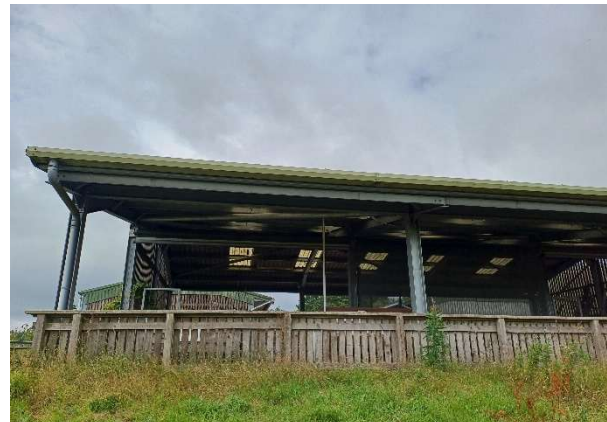
**05** General view of rear elevation.

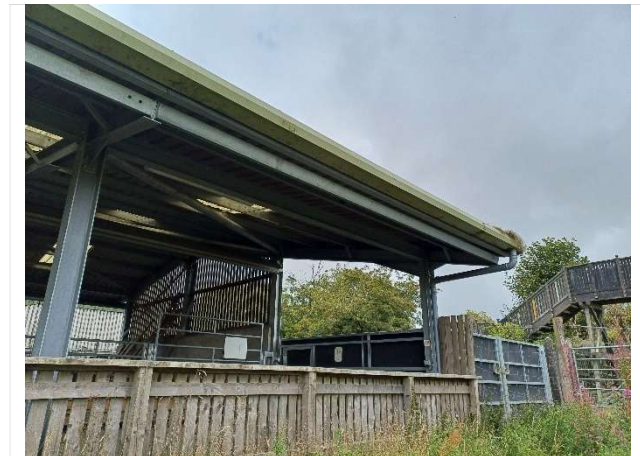
**06** General view of rear elevation showing build-up of vegetation in guttering.

- Overhaul gutters to remove all debris and vegetation
  - Allow for redecoration of all external timber cladding.
  - Allow for redecoration of both faces of 1.5m height wooden fencing.

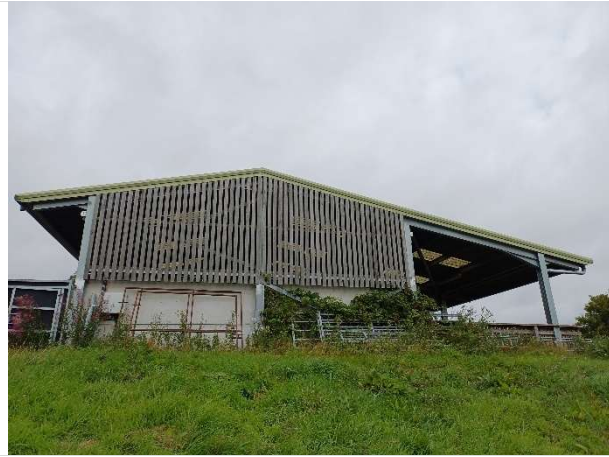
**07**

General view of right elevation. Clutter and vegetation build up at low level.

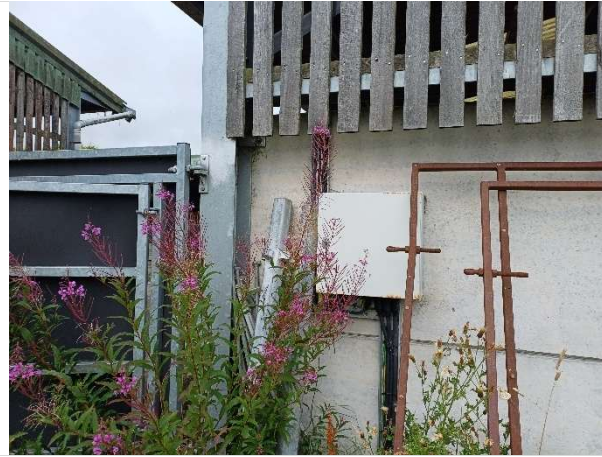
**08**

Electrical board on right external elevation. Access restricted due to vegetation and fencing.

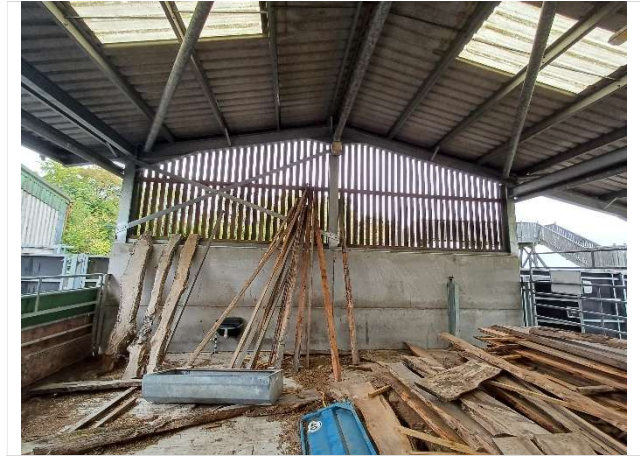
**09**

General view of internal LHS elevation. Space disorganised with various items.

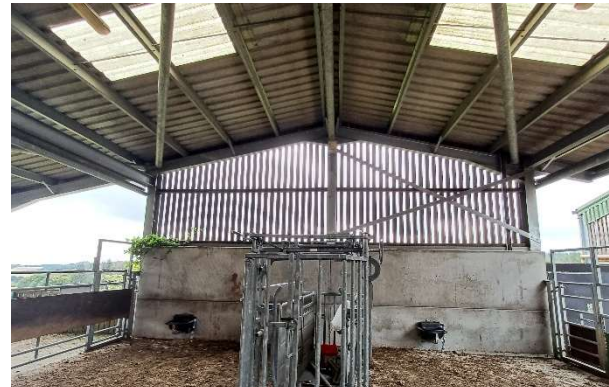
**10**

General view of internal RHS elevation.

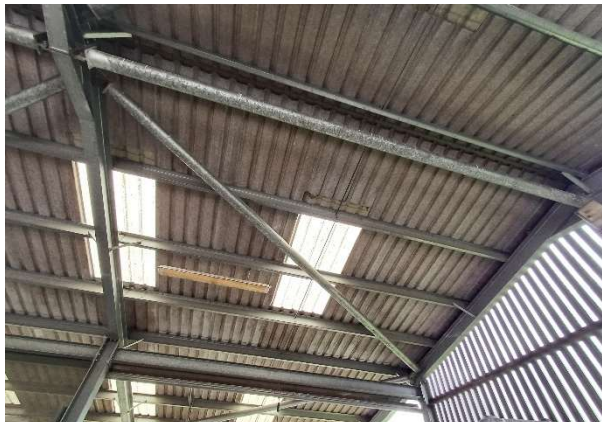
**11**

General internal view of roof covering, structure, and lighting.

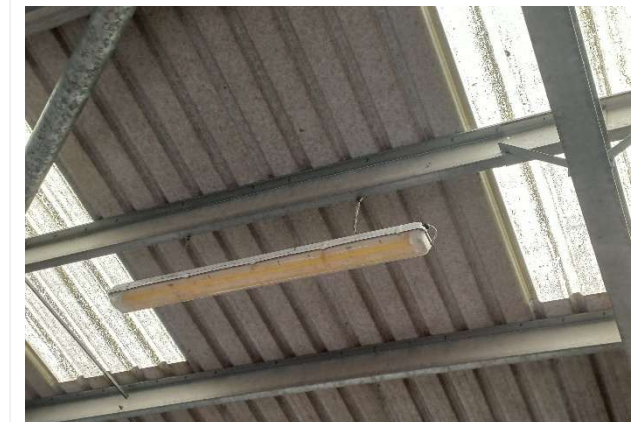
**12**

- 4.10.6 The strip lighting was observed to be in satisfactory condition with no visible defects.
- 4.10.7 The control switch was observed to be in good condition with no significant defects.
- 4.10.8 The internal white metal, lockable enclosure was observed to be in satisfactory condition with no significant defects.
- 4.10.9 The external white metal, lockable enclosure was observed to be in satisfactory condition with no significant defects.
- 4.10.10 The fuse spurs were observed to be in good condition with no significant defects.

Example of strip lighting within building.

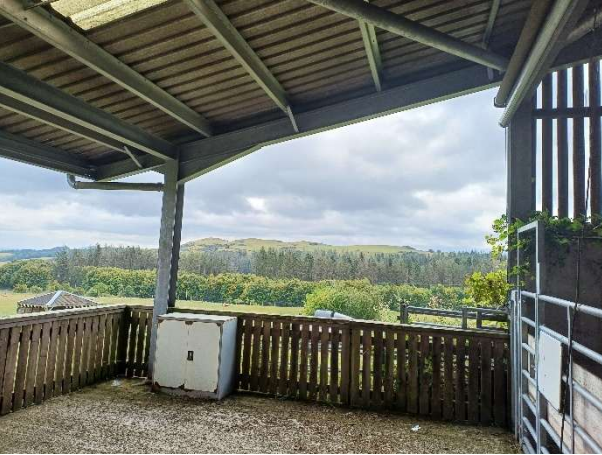
13

External electrical infrastructure, showing enclosure to be weathered due to exposure.

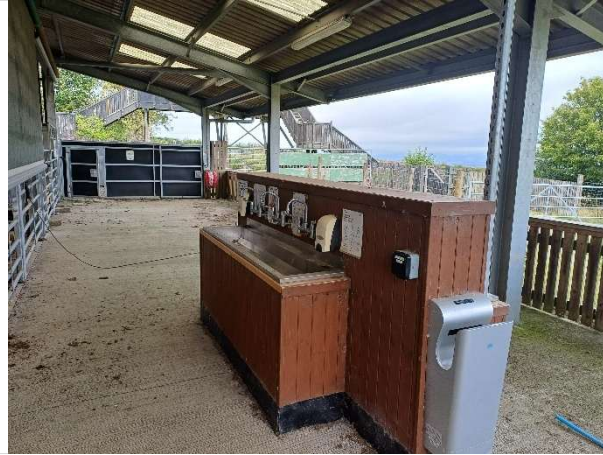
14

General view of handwash station in rear of building

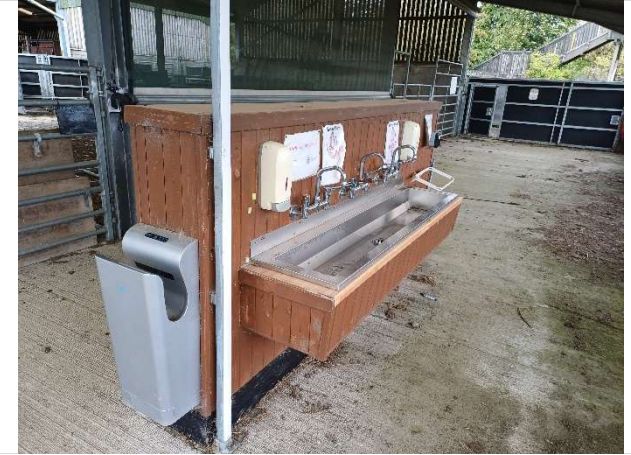
15

Handwash station operational but showing signs of wear.

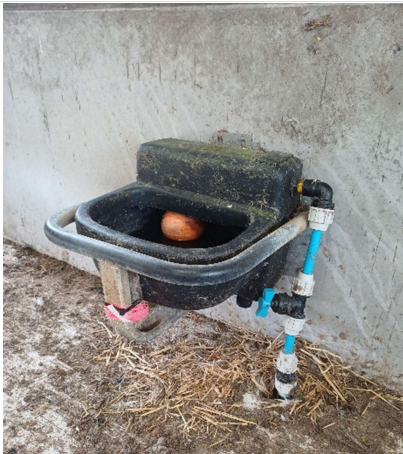
16

Livestock waterer, wall mounted to left and right internal elevations. Seems operational but cleaning and maintenance required.

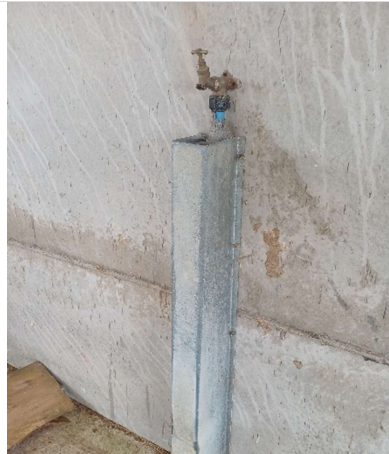
17

Wall mounted standpipe to left internal elevation.

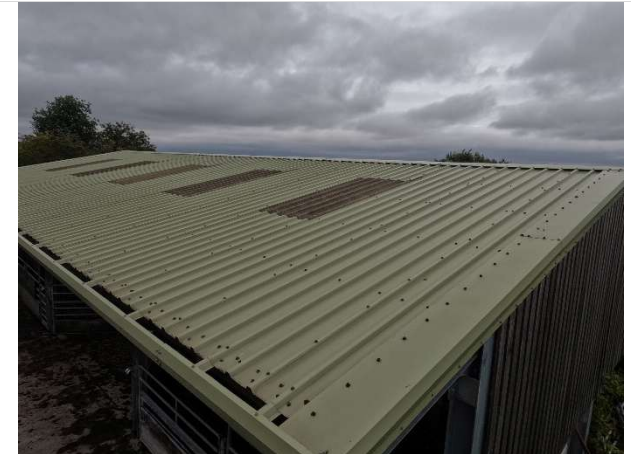
General view of front showing rooflights are soiled and weathered.

- 4.2.4 The roof structure was observed to be in satisfactory condition with no significant defects noted.
- 4.2.5 The corrugated metal sheeting was observed to be in satisfactory condition. It is recommended as a standard priority to abrade loose coating back to sound metal and apply cut-edge corrosion treatment to prolong lifespan.
- 4.2.6 The corrugated roof lights were observed to be in satisfactory condition. It is recommended that as a standard priority to clean rooflights thoroughly and apply coating of Delglaze (protective coating).

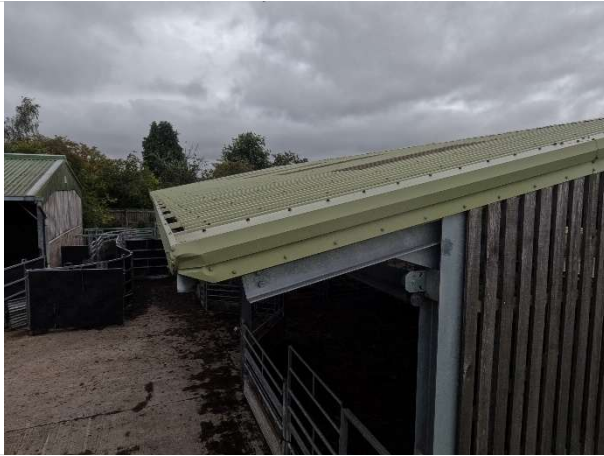
**19**

Minor damage to corner of roof covering/gutter

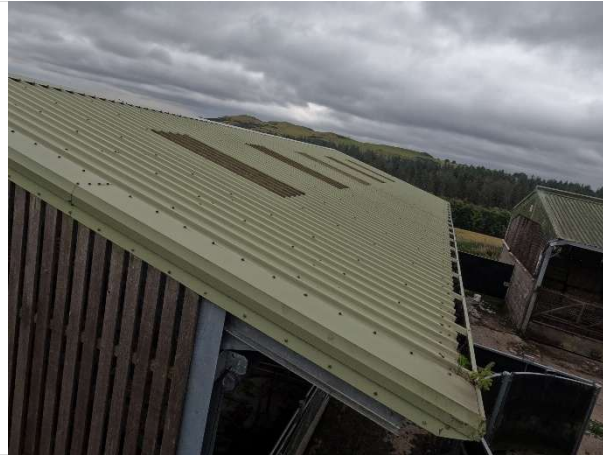
**20**

Debris build up in guttering on front pitch.

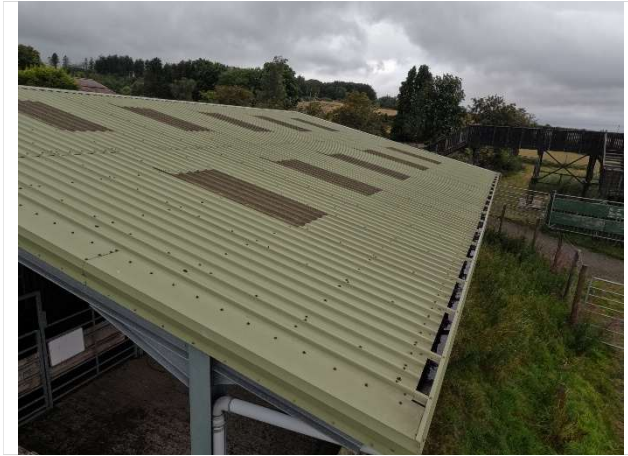
**21**

General view of rear pitch showing overall good condition.

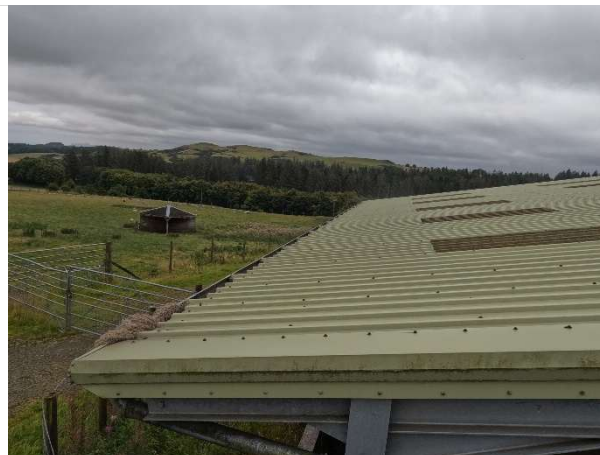
**22**

Vegetation build-up in guttering on rear pitch.
