West Lothian Council

Condition Surveys 2023

Beecraigs Deer Farm Machinery Store & Workshop,  
Linlithgow

10 July 2023

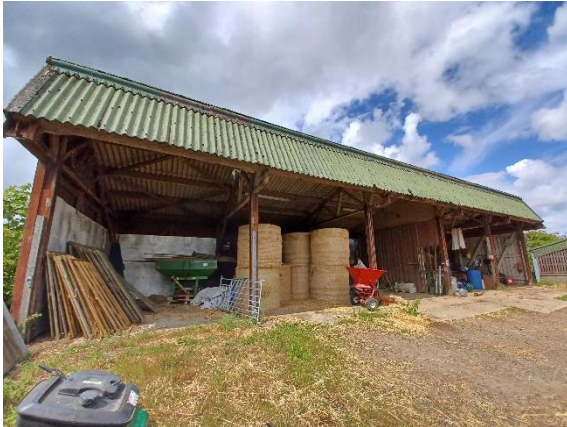
**Photo 1:** General view of principal elevation

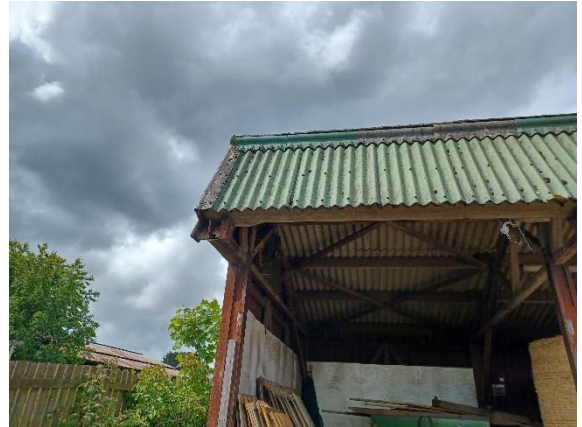
**Photo 2:** Structure comprising timber frame with corrugated asbestos cement sheet cladding, asbestos verge caps and cladding angles.

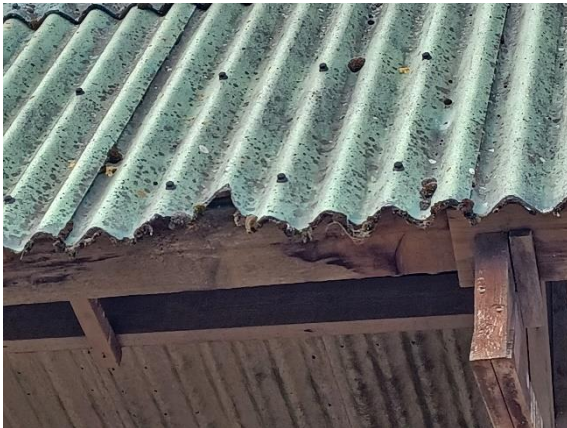
| Element | Description | Condition |
|---|---|---|
| <b>Roof</b> | Timber frame with asbestos cement sheet cladding. UPVC gutters to rear elevation. | Damage to leading edge of roof over principal elevation. Gutters heavily choked and required cleaning. |

**Photo 3:** One of several damaged asbestos sheets at leading edge of canopy.

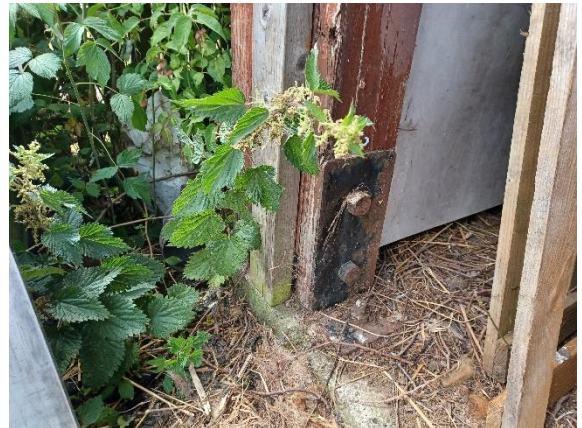
**Photo 4:** Column connection to ground slab.

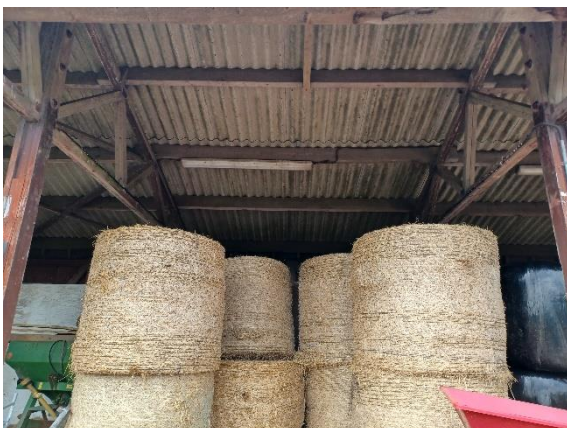
**Photo 5:** General view within machinery shed, restricted access.

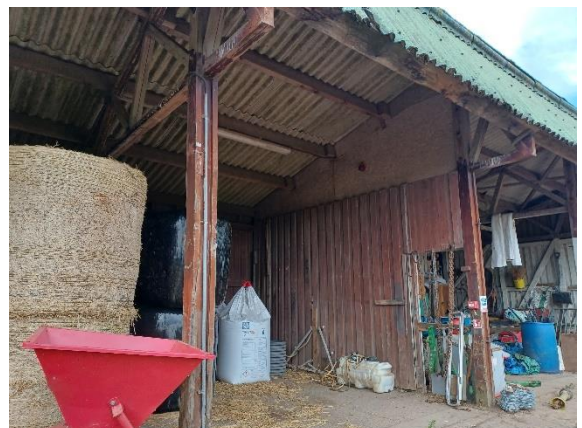
**Photo 6:** General view to RHS of storage shed.

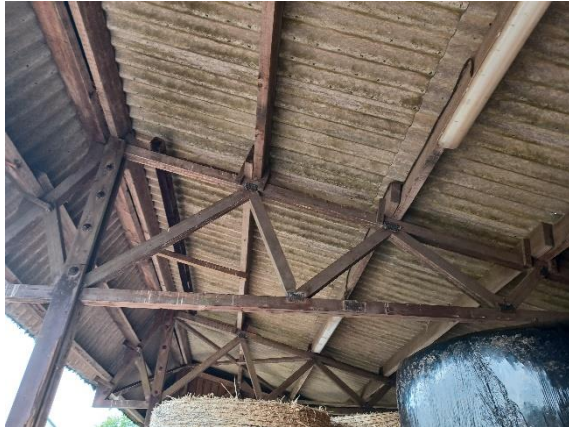
**Photo 7:** General view of underside of roof.

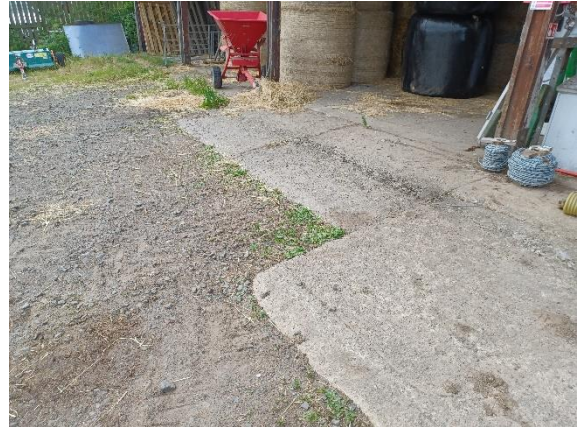
| Element | Description | Condition |
|---|---|---|
| <b>Floors &amp; Stairs</b> | Ground-supported concrete slab, no stairs present. | Weathered and worn, commensurate with age and use. |

**Photo 8:** Entrance to LHS of shed, concrete slab in fair condition with localised deterioration.

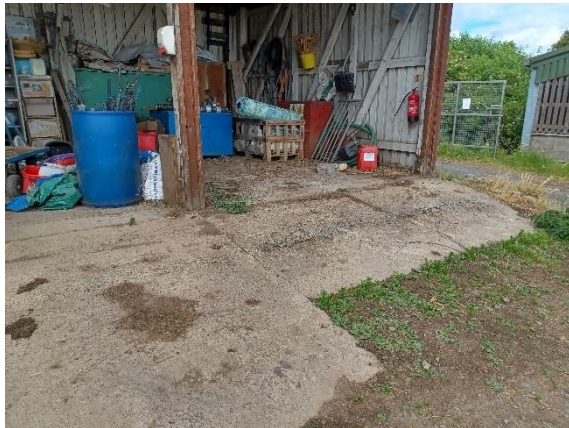
**Photo 9:** Entrance to LHS of shed, concrete slab in fair condition with localised deterioration.

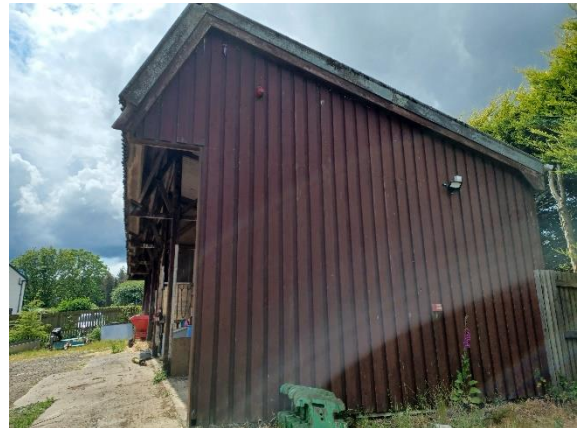
**Photo 10:** General view of east elevation

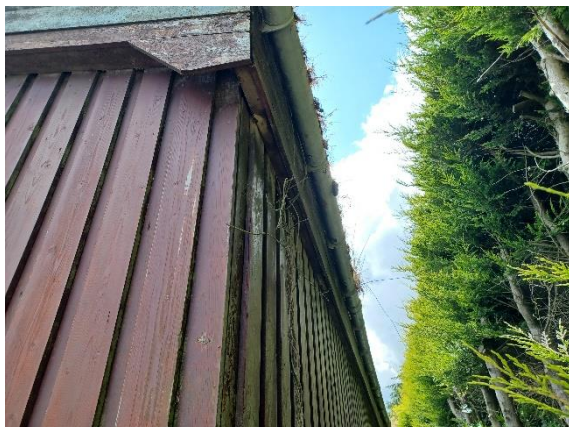
**Photo 11:** General view of rear elevation, gutter choked with vegetation.

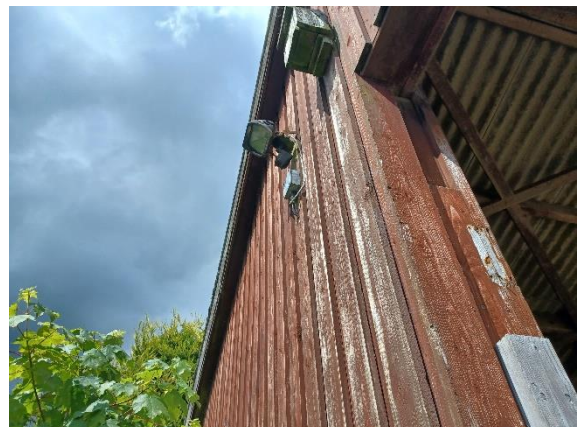
**Photo 12:** General view west elevation.

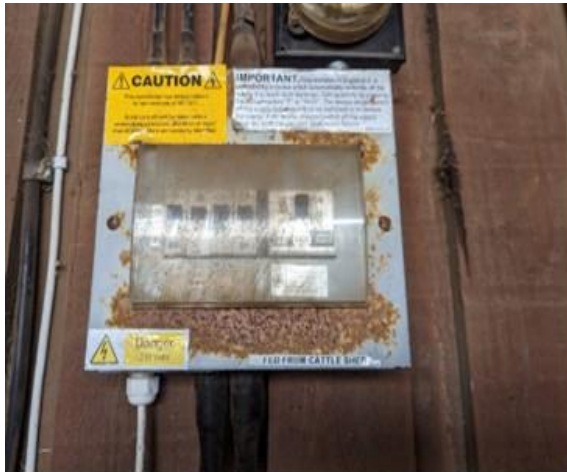
**Photo 13:** Machinery Shed distribution board rusted and due to be replaced.

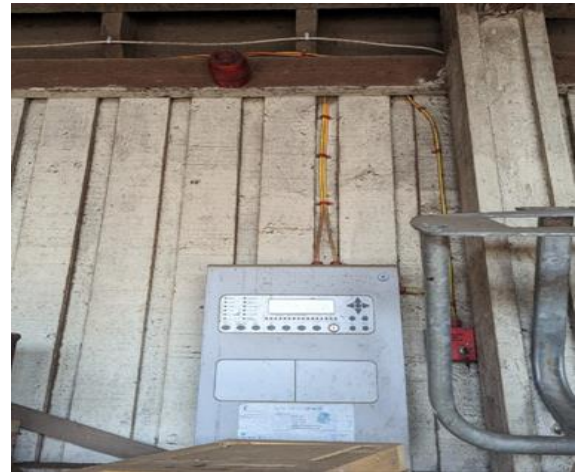
| Element | Description | Condition |
|---|---|---|
| Fire Alarm & Other Fire Systems | Not working fire alarm panel in the cattle shed | Not working and should be removed only if it is not required for asset protection. |

**Photo 14:** Non-working fire alarm panel in Machinery Shed.
